This hand-moulded facing brick is made from loess, which is extracted among others from the Kesselt plateau in the Maas valley (Belgium) and then enhanced with raw materials from the Volcanic Eifel.

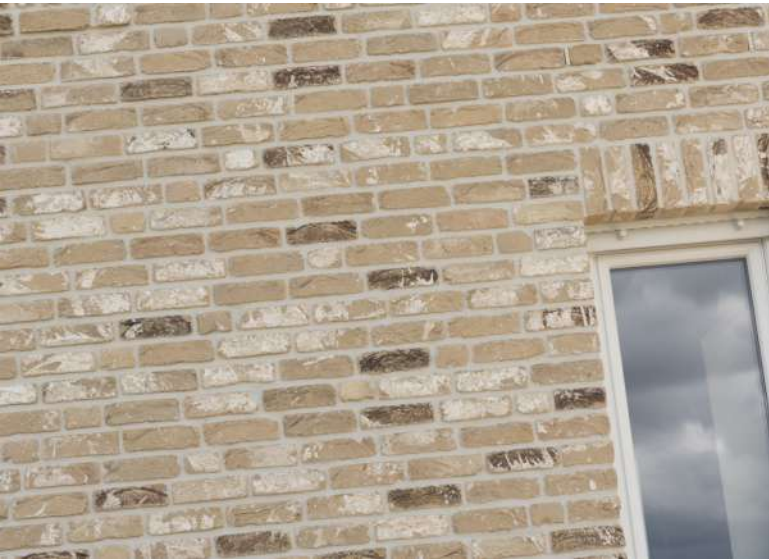
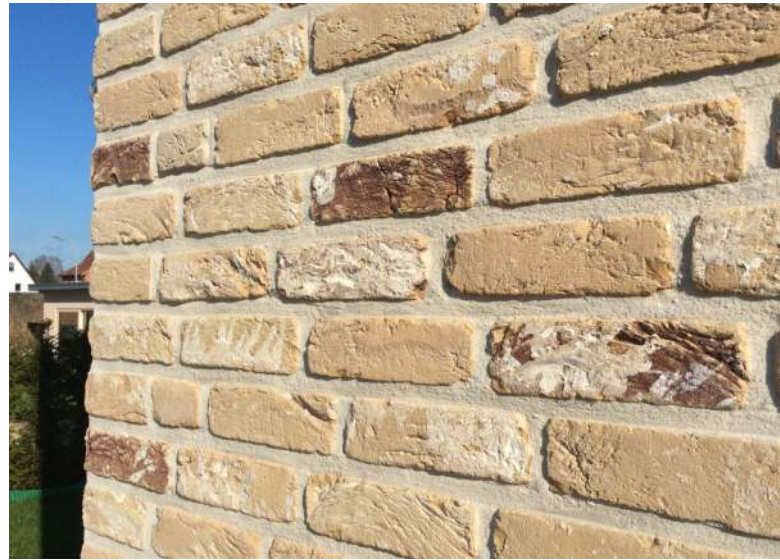
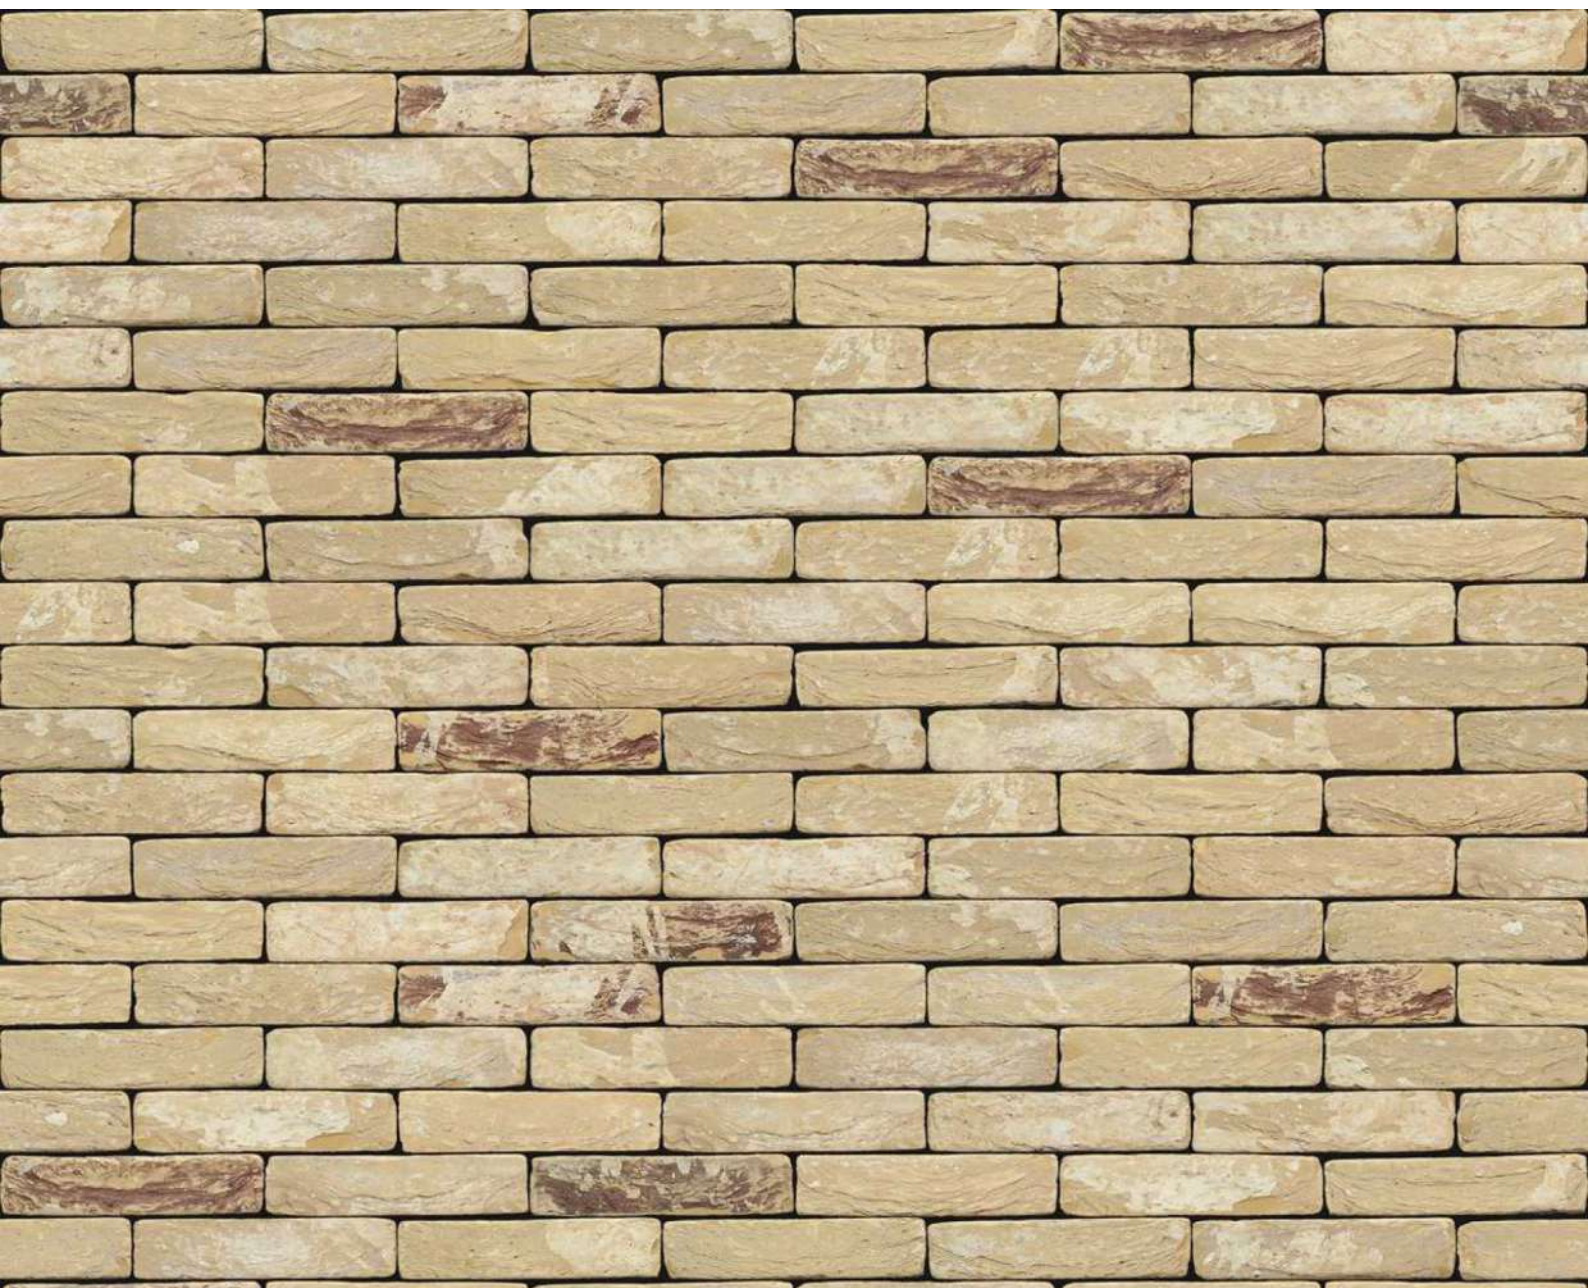
The (non-perforated) facing brick is sanded on five sides. The surface may be given a frog (a slanted oblong groove) on its bed. The firing process takes place in a gas-heated tunnel kiln. The bricks have a rough structure, irregular shape, and a strong resemblance to recovered bricks. The brick's retro appearance is achieved by using a tumbling process.

The brick has a yellow base. The mainly beige-yellow hue has an overall ecru effect with scattered pink-brown shadings and white calcareous sediments. The colours shown are a near reflection of reality.
