This hand-moulded facing brick is made from loess, which is extracted among others from the Kesselt plateau in the Maas valley (Belgium) and then enhanced with raw materials from the Volcanic Eifel.

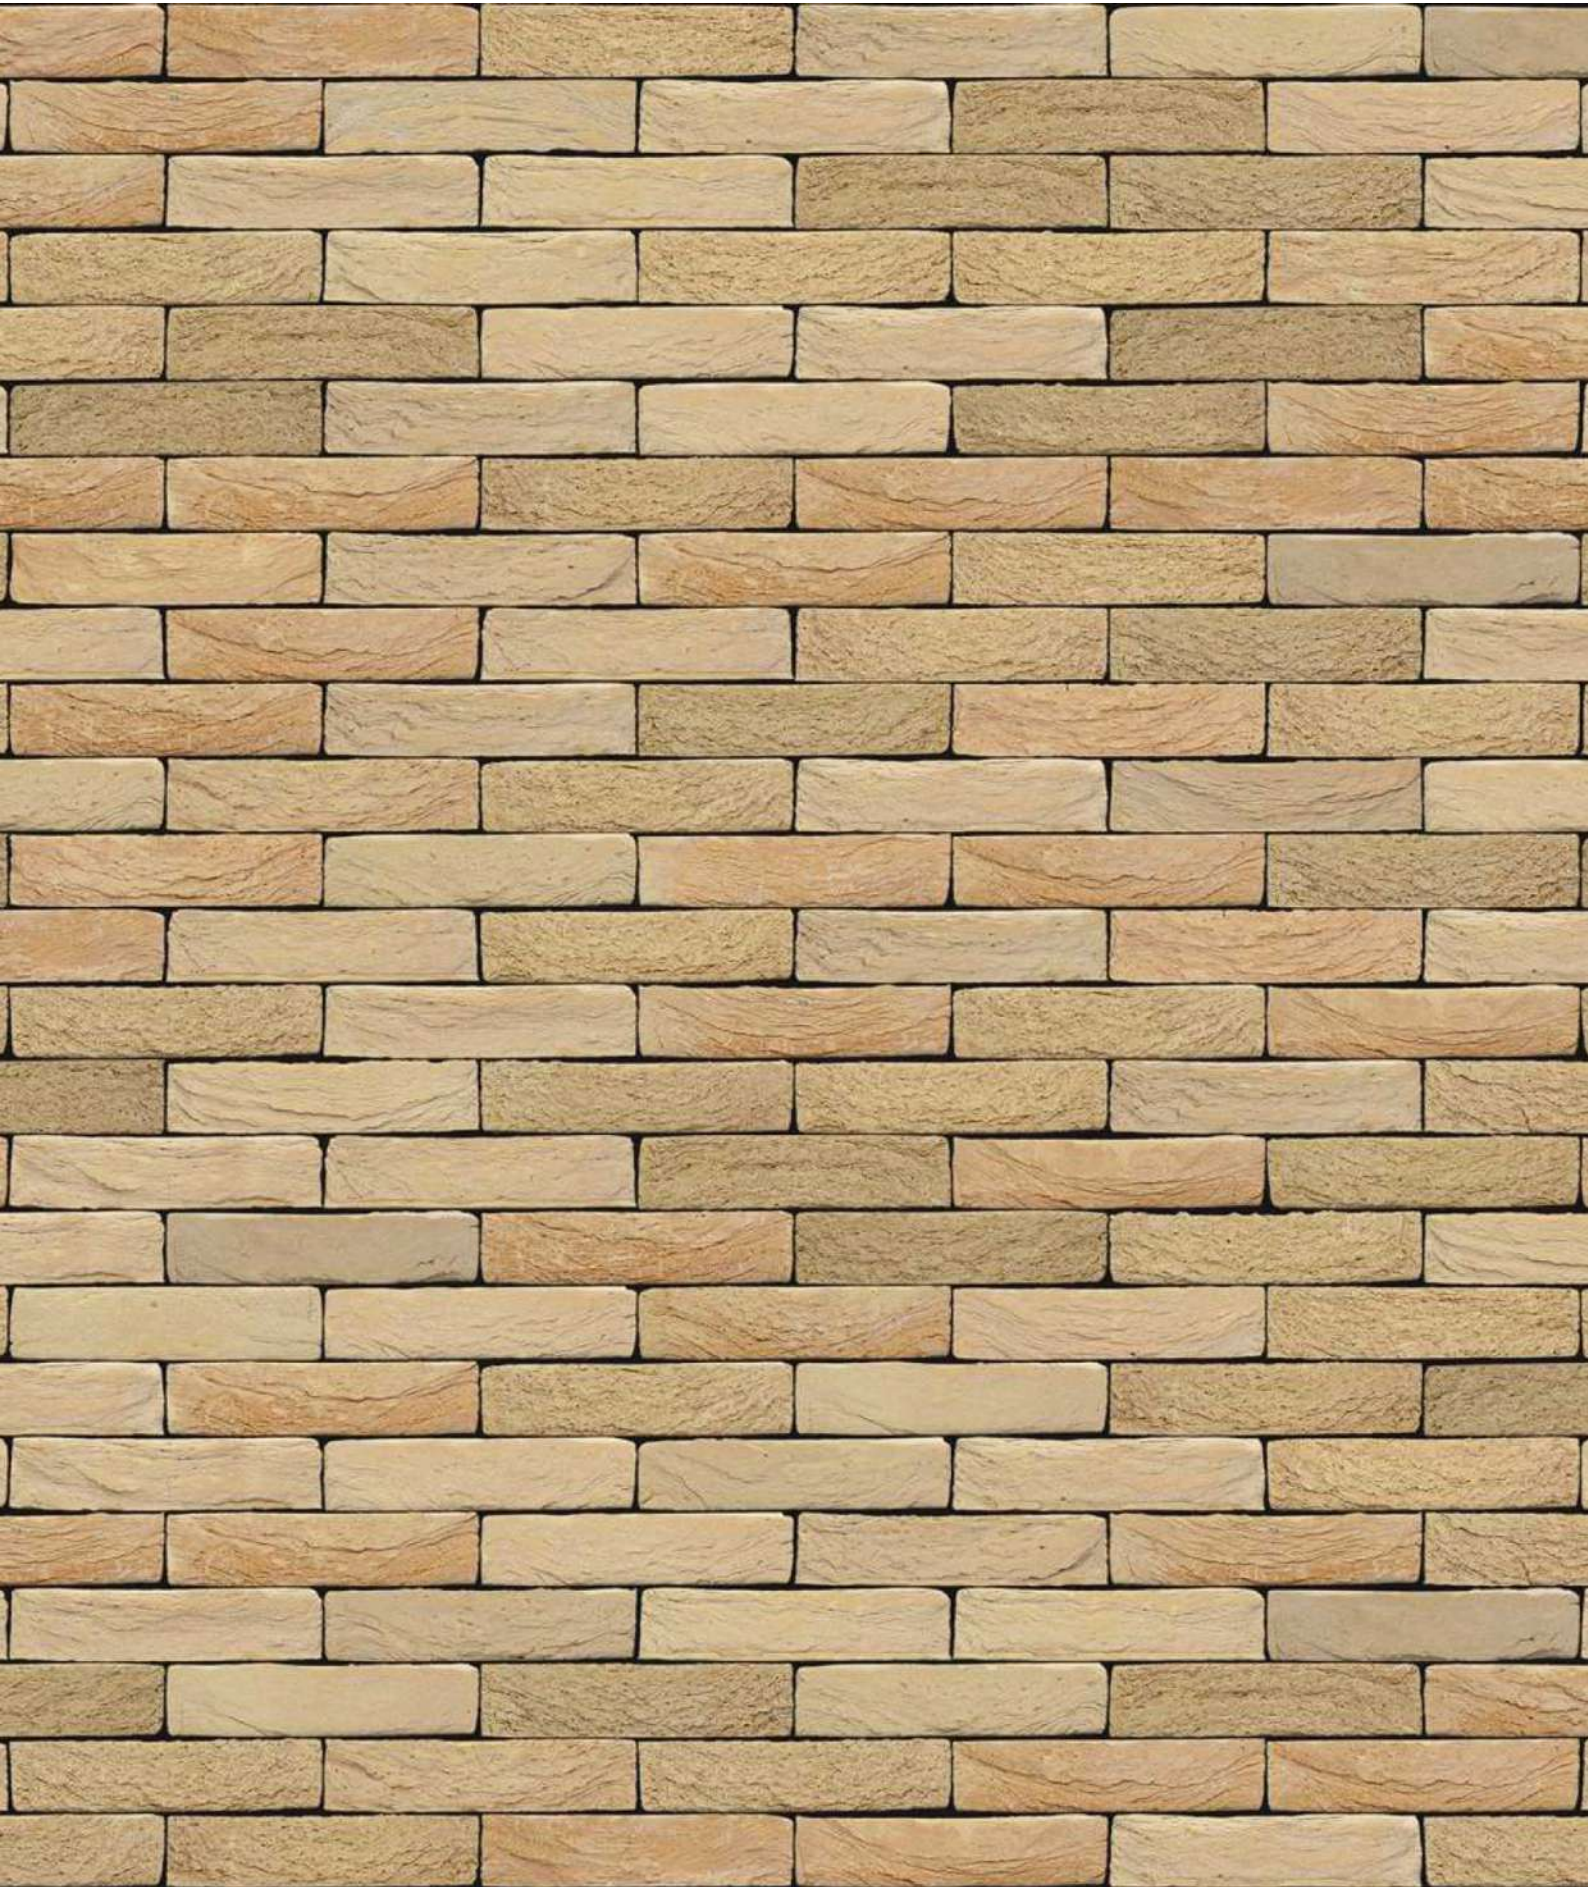
The (non-perforated) facing brick is sanded on five sides. The surface may be given a frog (a slanted oblong groove) on its bed. The structure looks rugged with fine and irregular grooves in the sandy surface. The firing process takes place in a gas-heated tunnel kiln.

The brick has a yellow base. The colour shading consists of variations of yellow with light-pink tones. The different structures are the result of sawdust on the one hand and white, fine-grained sand on the other. The colours shown are a near reflection of reality.
