This hand-moulded facing brick is made from loess, which is extracted among others from the Kesselt plateau in the Maas valley (Belgium) and then enhanced with raw materials from the Volcanic Eifel.

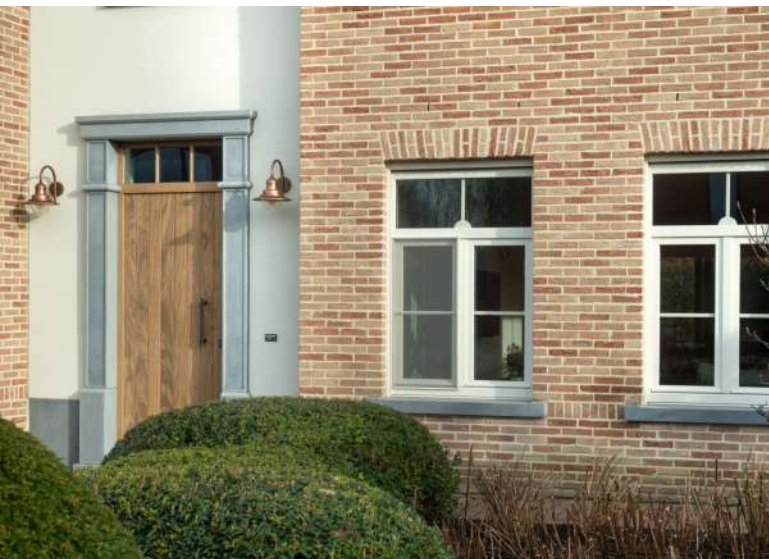
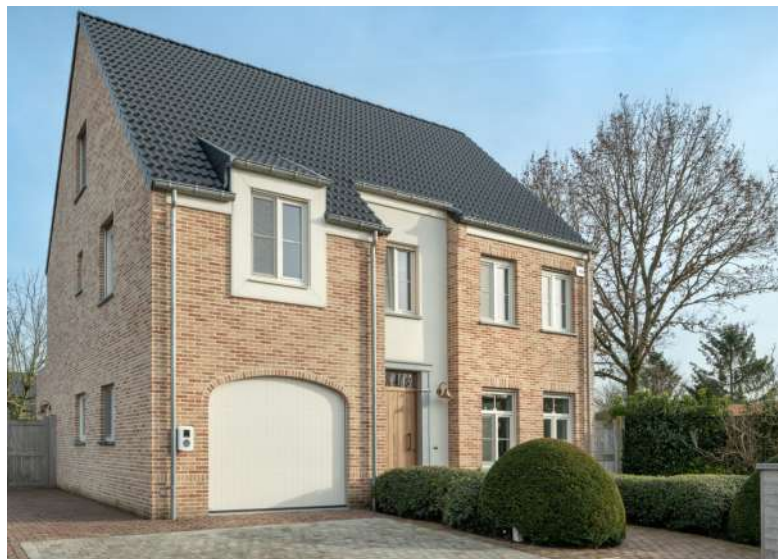
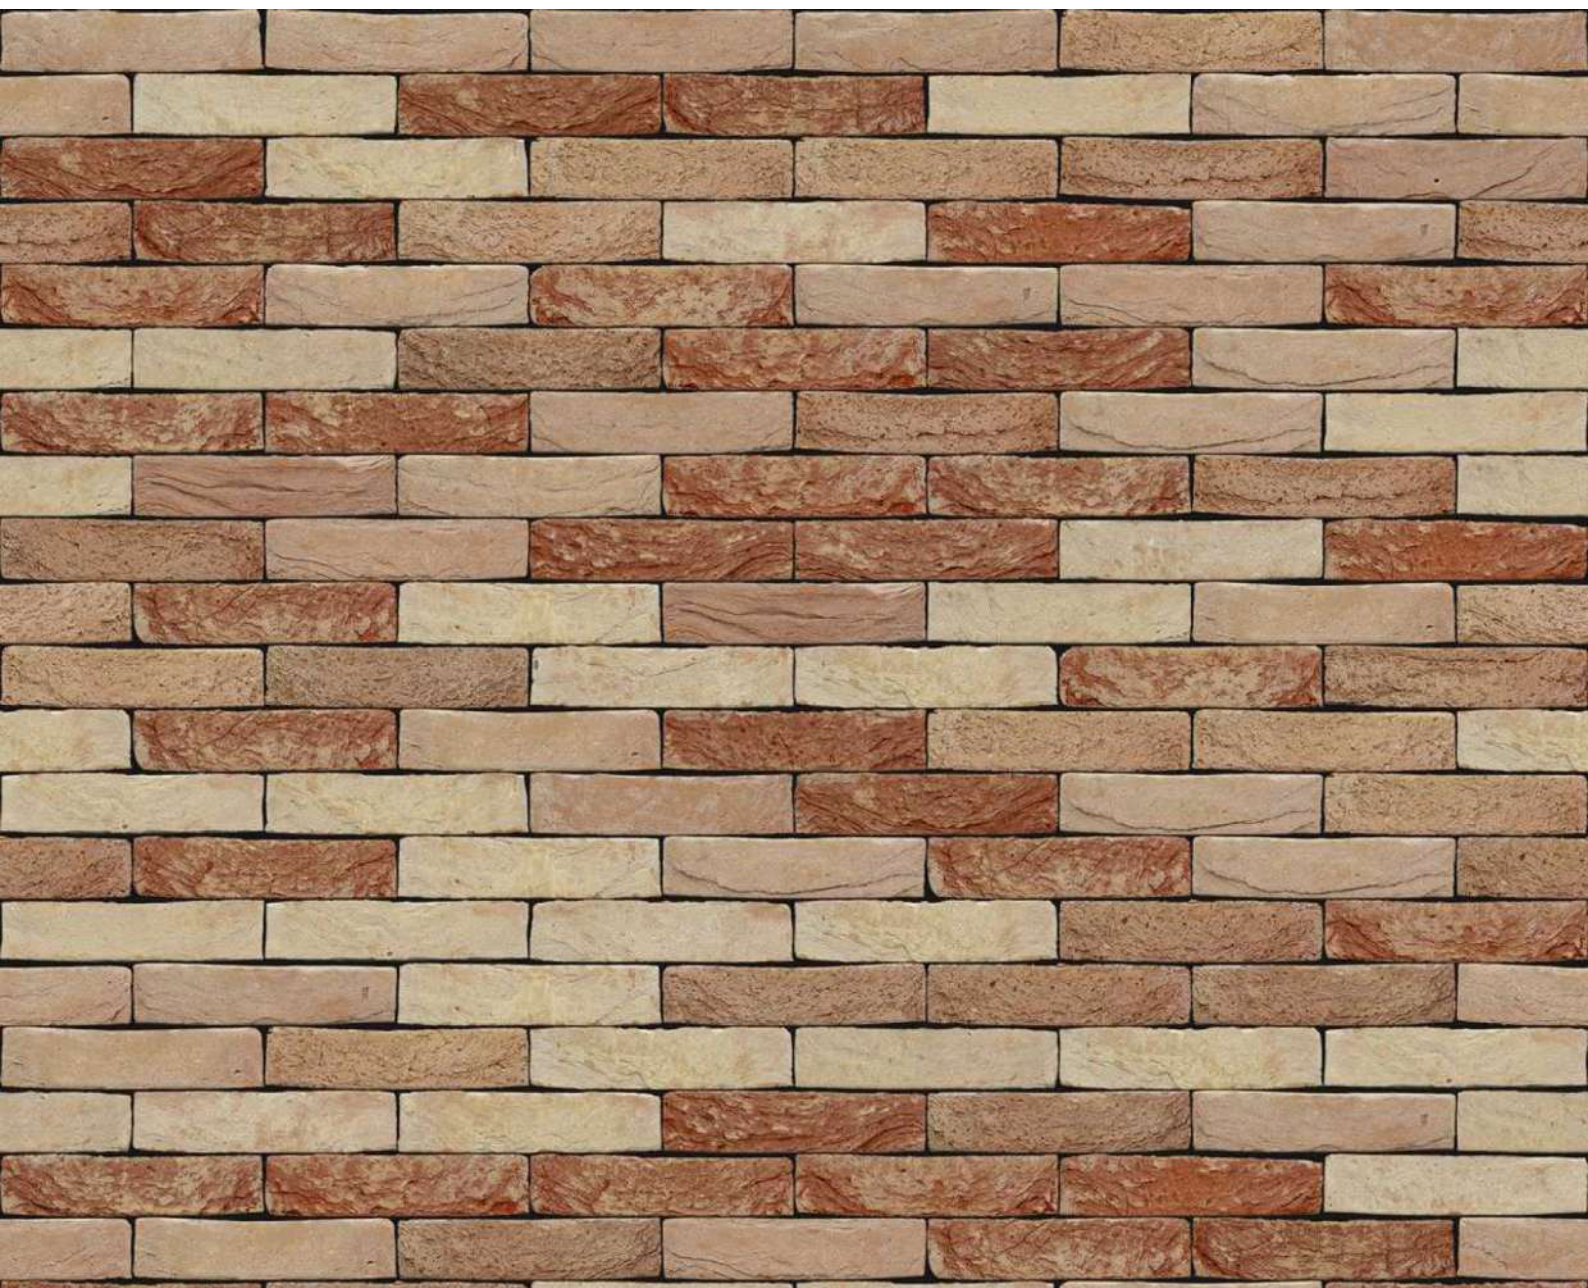
The (non-perforated) facing brick is sanded on five sides. The surface may be given a frog (a slanted oblong groove) on its bed. The structure looks rugged with fine and irregular grooves in the sandy surface. The firing process takes place in a gas-heated tunnel kiln.

The brick has a pink base, and the colour variations contain soft pastel coloured shadings of grey-yellow, pink-red and ochreous brown in accurately defined proportions. The different structures are the result of sawdust on the one hand and white, fine-grained sand on the other. The colours shown are a near reflection of reality.
