This hand-moulded facing brick is made from loess, which is extracted among others from the Kesselt plateau in the Maas valley (Belgium) and then enhanced with raw materials from the Volcanic Eifel.

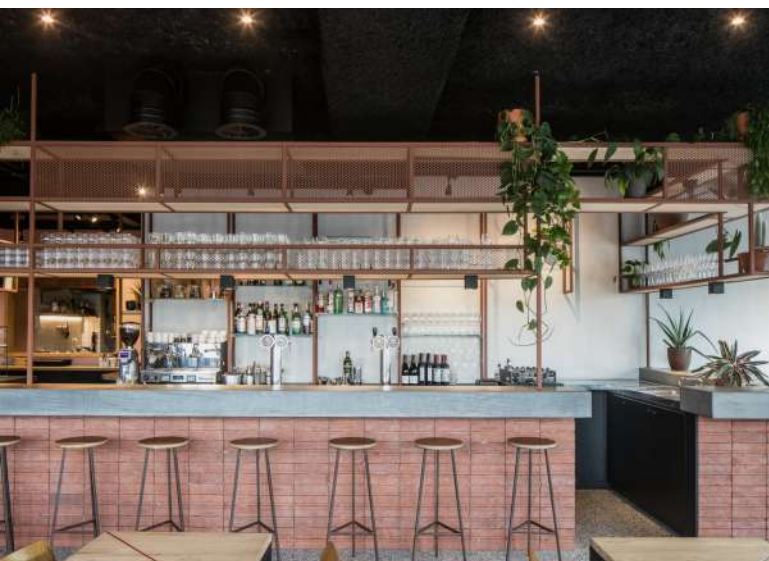
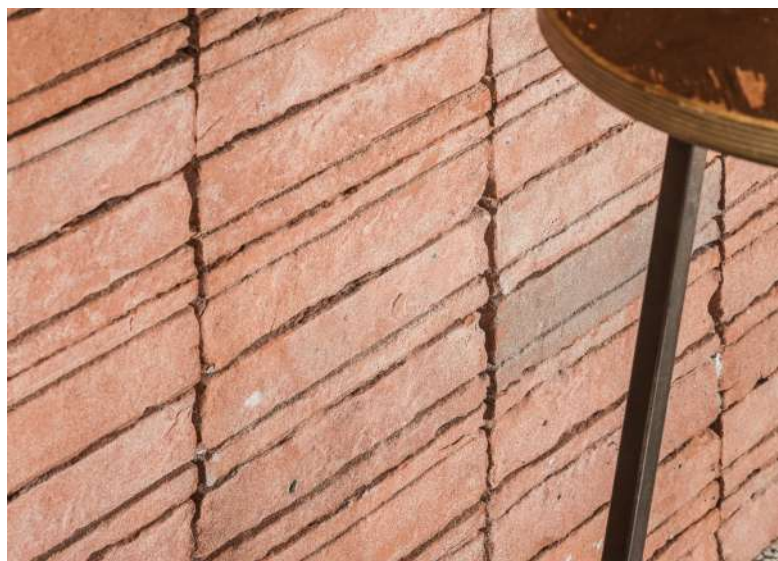
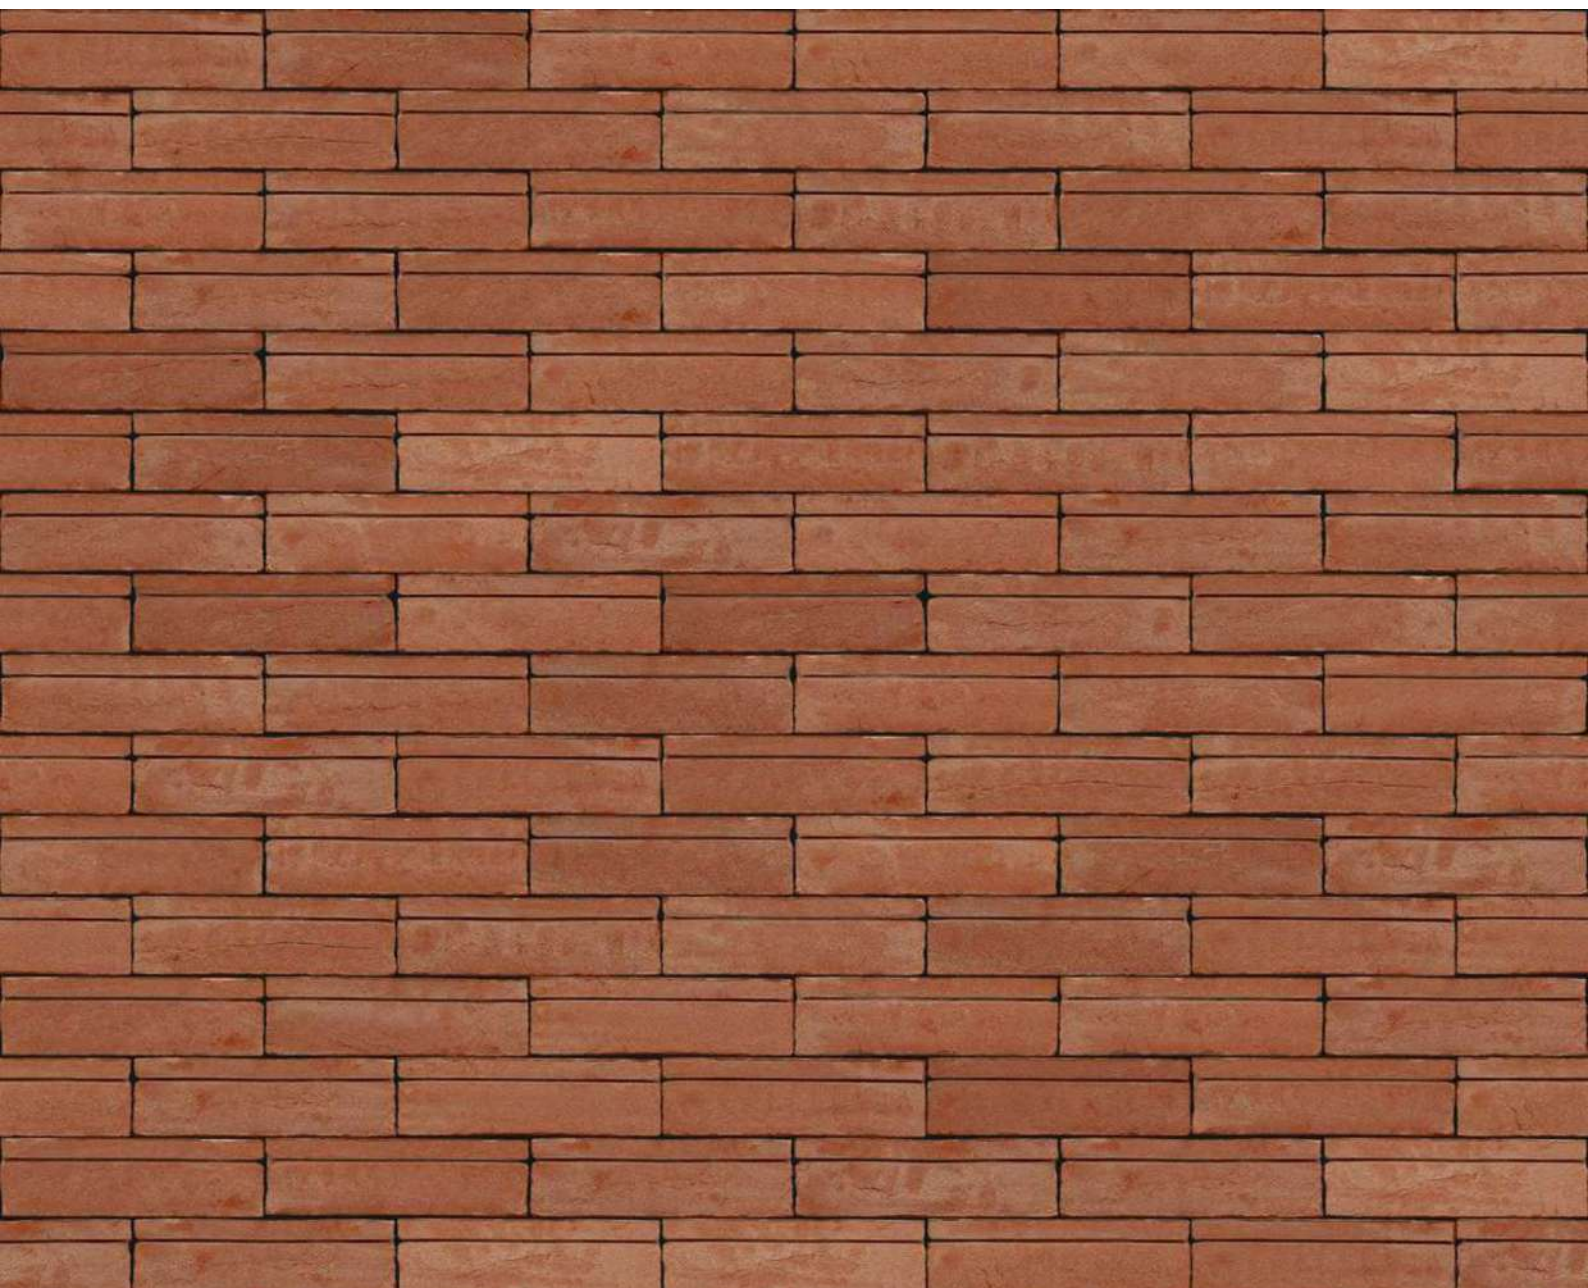
The (non-perforated) facing brick is sanded on five sides. The structure looks rugged with fine and irregular grooves in the sandy surface. The firing process takes place in a gas-heated tunnel kiln. DUBIO exists in 2 variants: DUBIO 1 = DUBIO with 1 shadow joint on the stretcher face (asymmetrical shadow joint) and DUBIO 2 = DUBIO with 2 shadow joints on the stretcher face (double symmetric shadow joint). The line pattern continues on at least one header face of the brick. The thickness of the shadow joint is  $\pm 4$ mm.

The brick has a red base with hues ranging from red to dark red. The rather neutral and even colour is the result of the red baking löss clay. The colours shown are a near reflection of reality.
