This hand-moulded facing brick is made from loess, which is extracted among others from the Kesselt plateau in the Maas valley (Belgium) and then enhanced with raw materials from the Volcanic Eifel.

ASPECT AND STRUCTURE

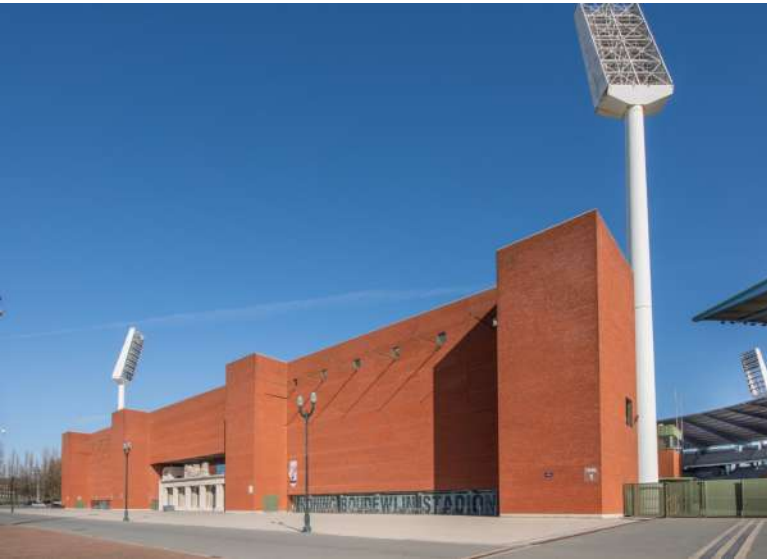
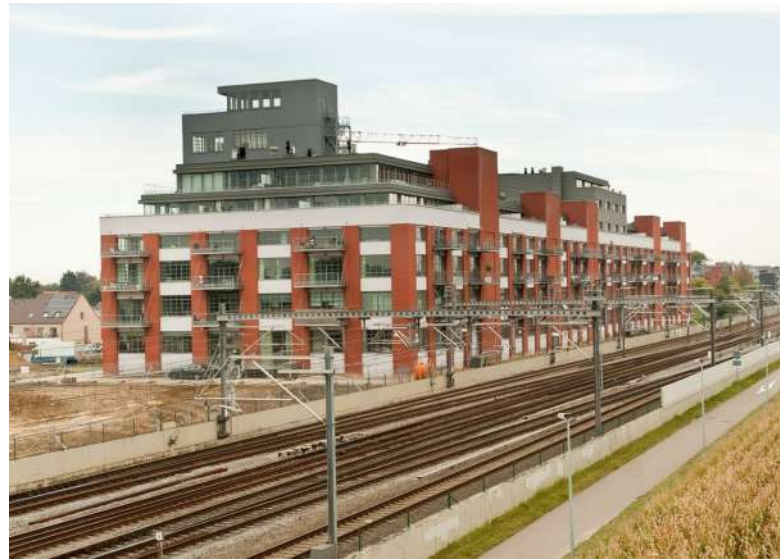
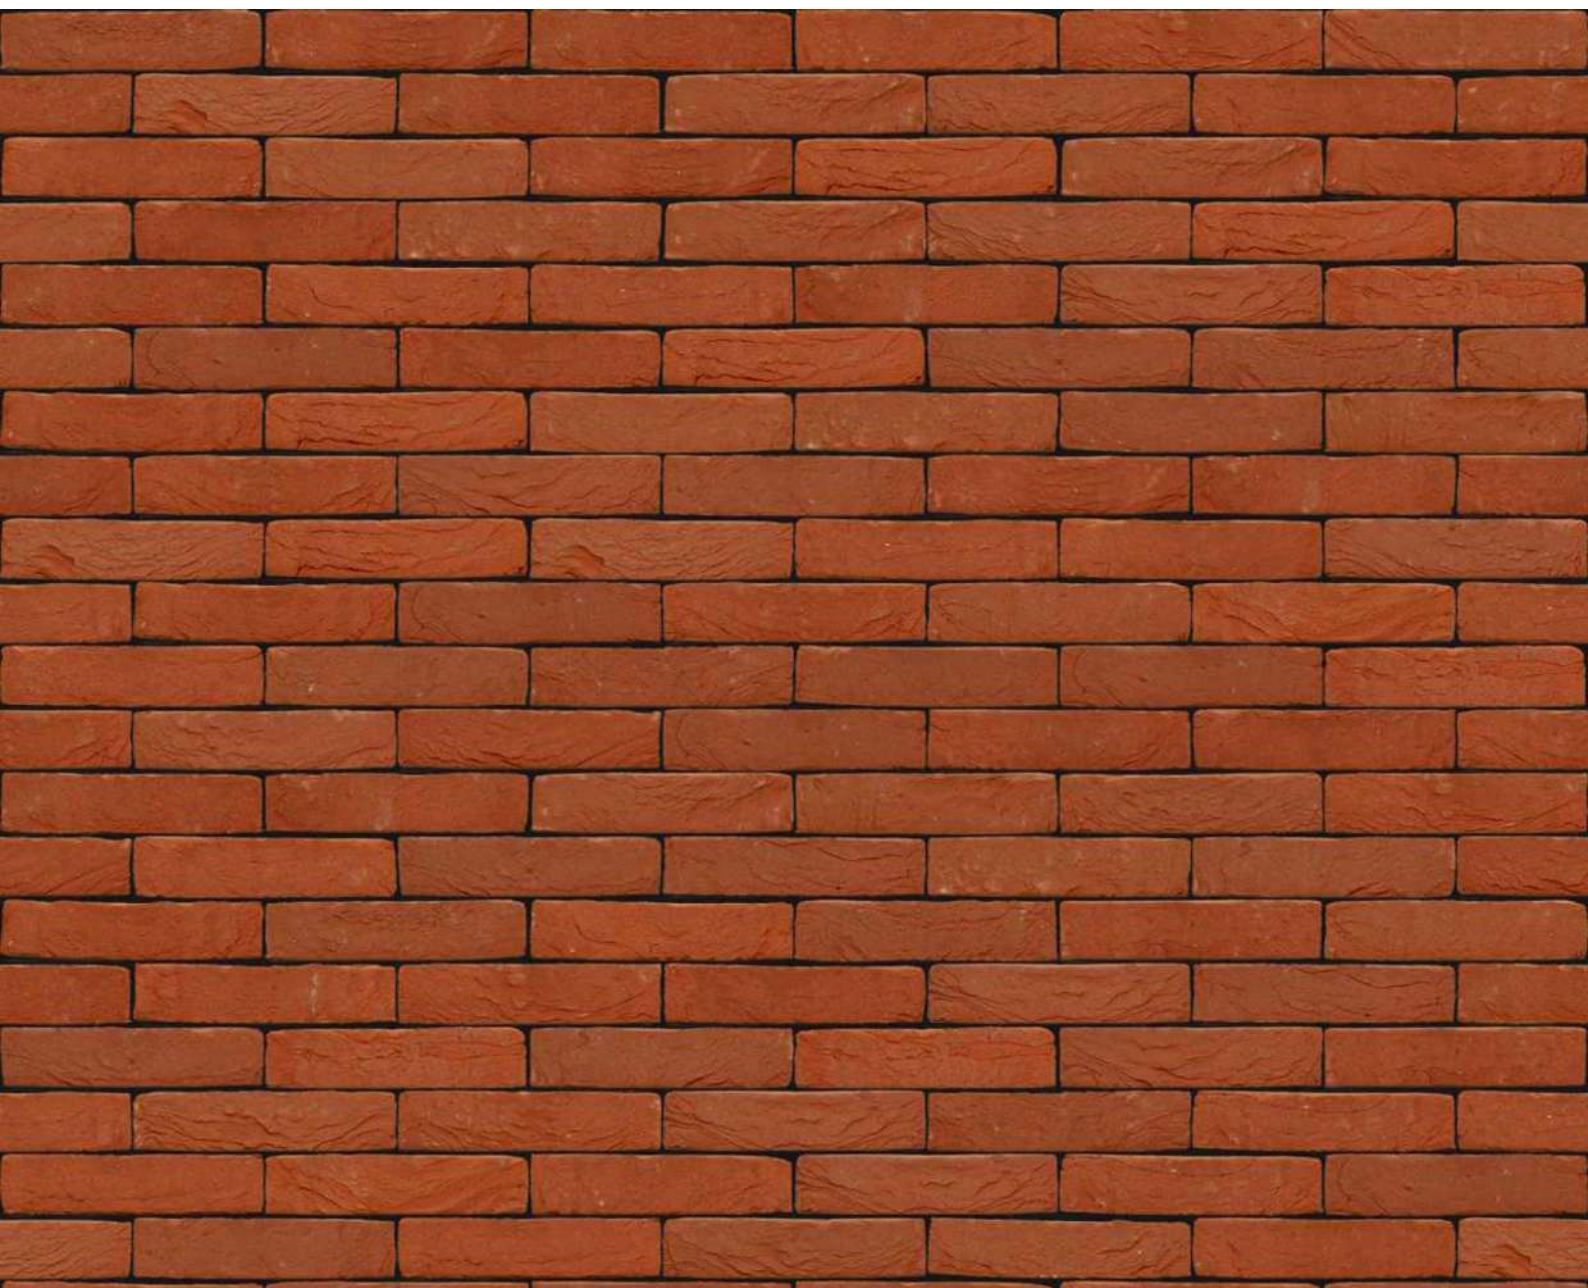
The (non-perforated) facing brick is sanded on five sides. The surface may be given a frog (a slanted oblong groove) on its bed. The structure looks rugged with fine and irregular grooves in the sandy surface. The firing process takes place in a gas-heated tunnel kiln.

The hues range from orange red to bright red as a result of the treatment and sanding of the typical red baking Kesselt löss clay with brownish-red fine-grained sand. The colours shown are a near reflection of reality.
