This hand-moulded facing brick is made from loess, which is extracted among others from the Kesselt plateau in the Maas valley (Belgium) and then enhanced with raw materials from the Volcanic Eifel.

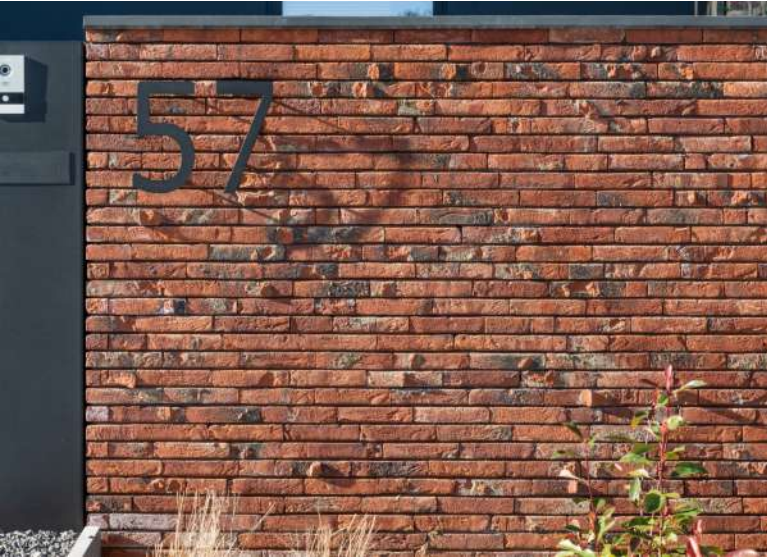
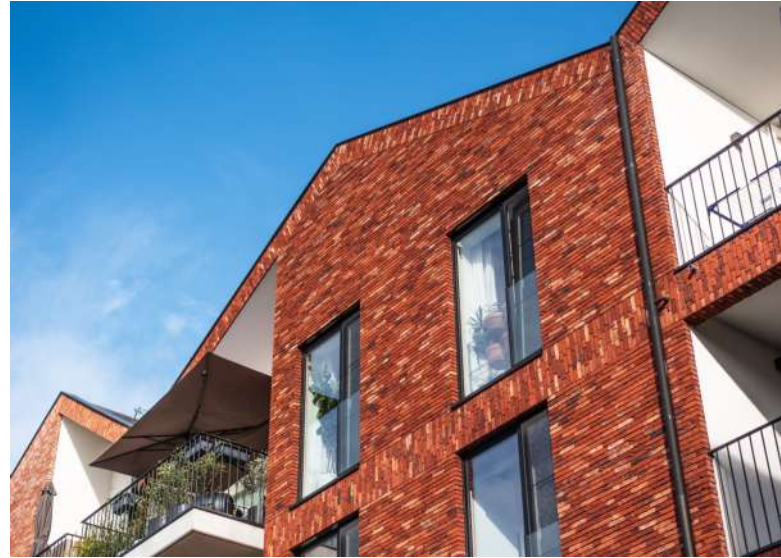
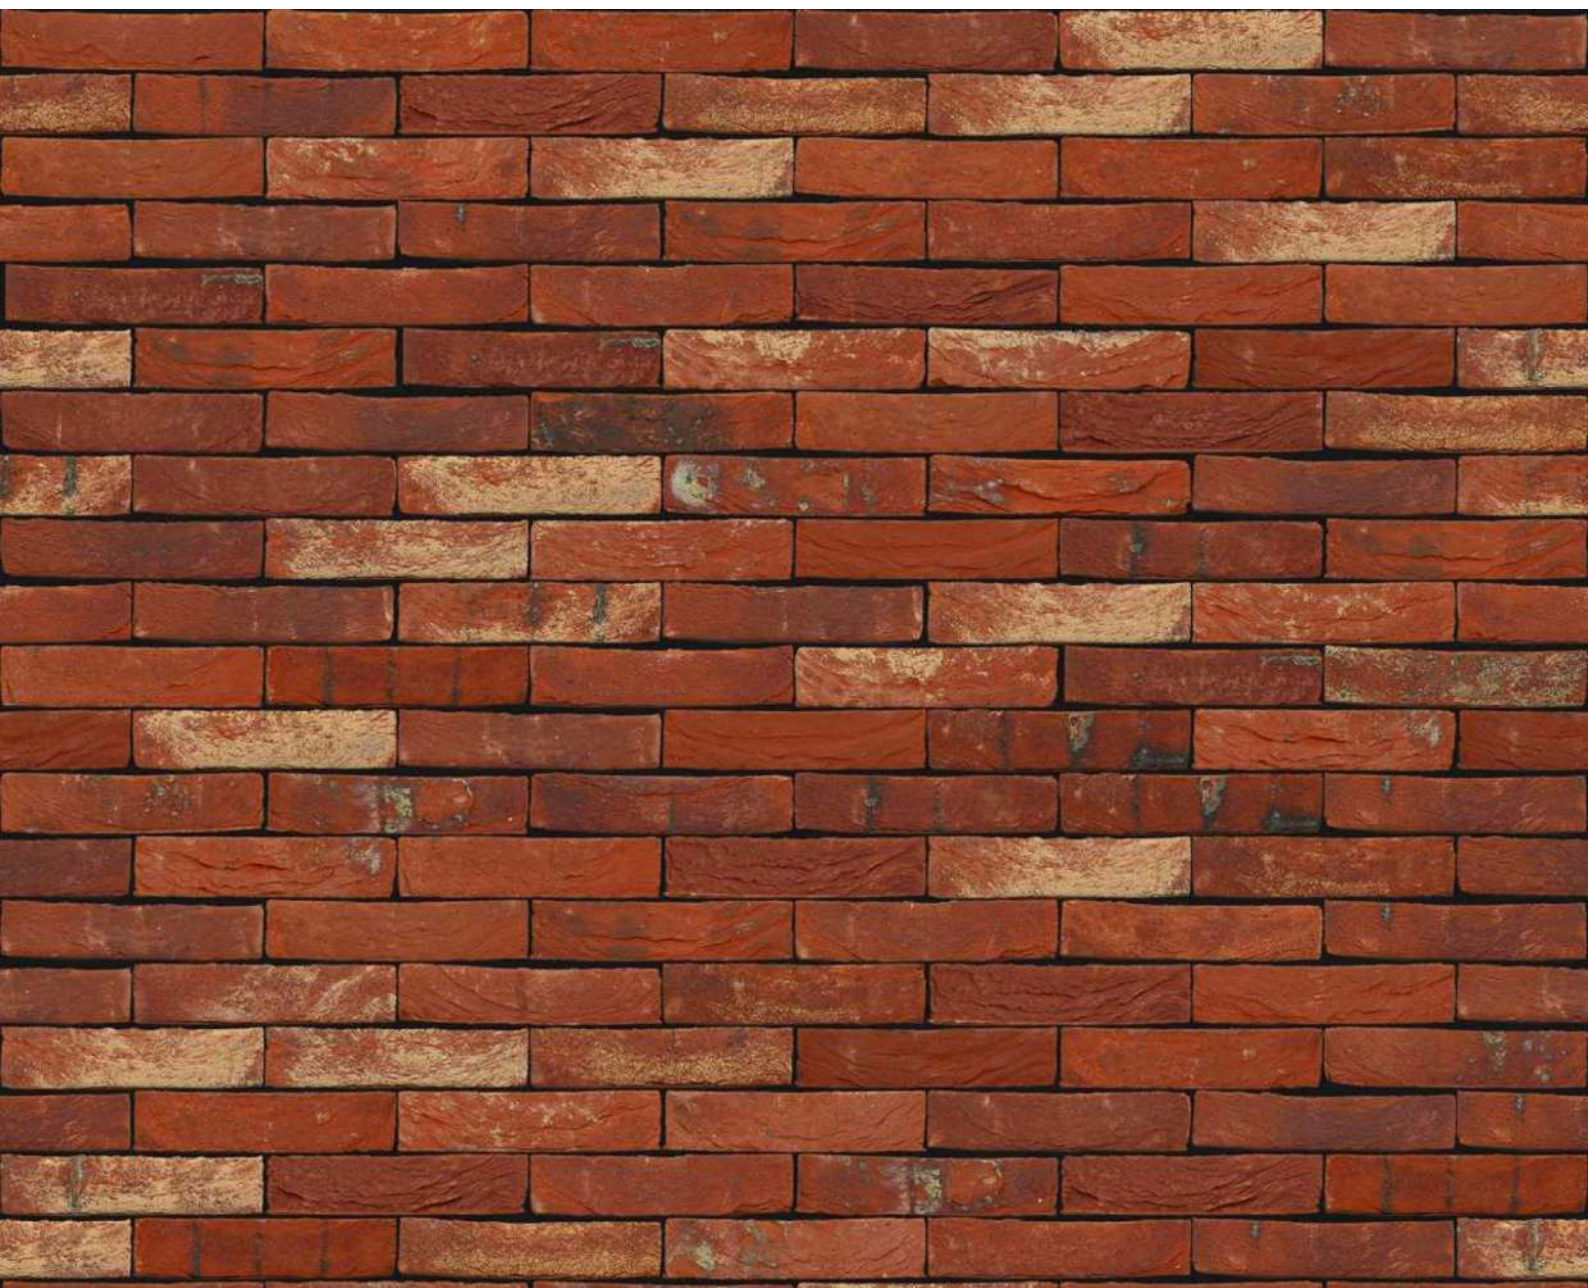
The (non-perforated) facing brick is sanded on five sides. The surface may be given a frog (a slanted oblong groove) on its bed. The structure looks rugged with fine and irregular grooves in the sandy surface. The firing process takes place in a gas-heated tunnel kiln.

The brick has a red base, with colours ranging from orange red to dark red. The darker shade on the facing brick is obtained by means of coalsintering. The colours shown are a near reflection of reality.
