This hand-moulded facing brick is made from loess, which is extracted among others from the Kesselt plateau in the Maas valley (Belgium) and then enhanced with raw materials from the Volcanic Eifel.

ASPECT AND STRUCTURE

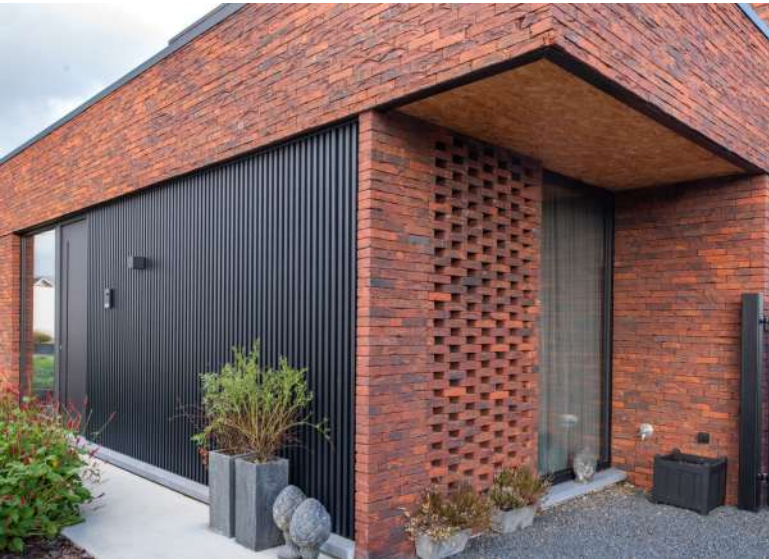
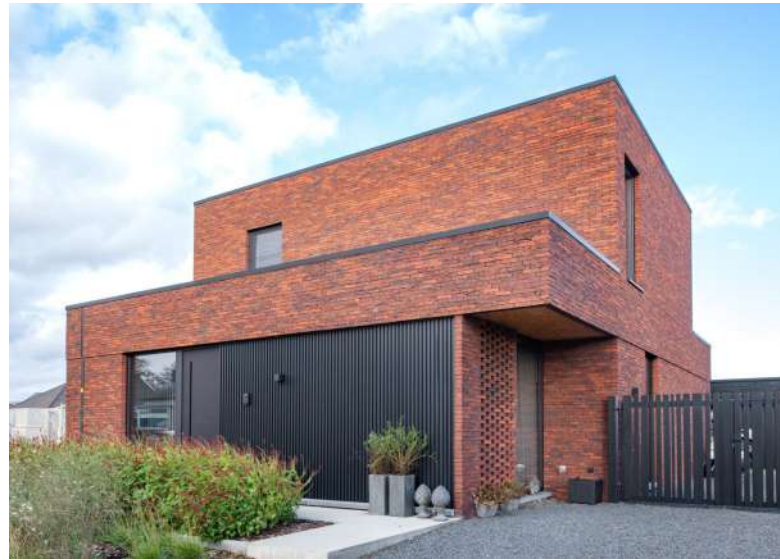
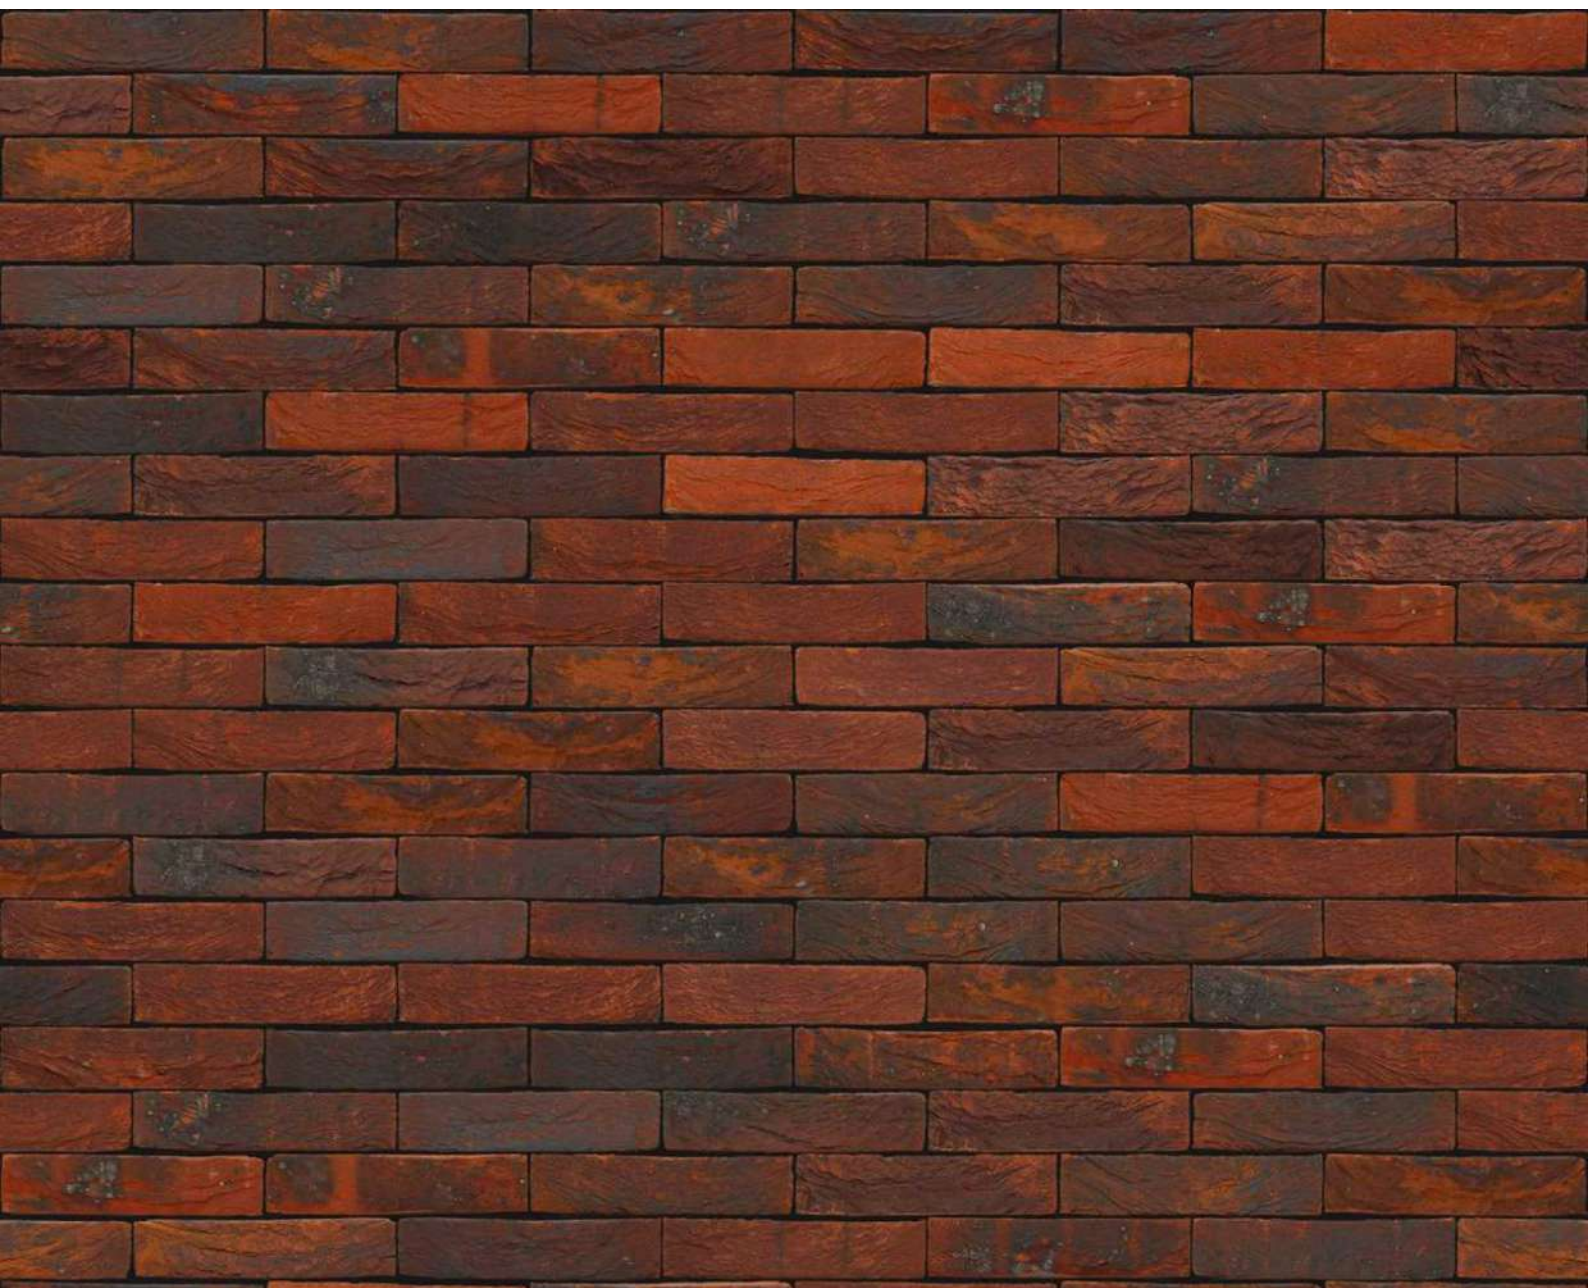
The (non-perforated) facing brick is sanded on five sides. The surface may be given a frog (a slanted oblong groove) on its bed. The structure looks rugged with fine and irregular grooves in the sandy surface. The firing process takes place in a gas-heated tunnel kiln.

The brick has a red base, with hues that vary from orange red to burgundy with blue, yellow-green and dark-purple shades. Through sintering of the brick, the different nuances of colour are obtained. The colours shown are a near reflection of reality.
