This hand-moulded facing brick is made from loess, which is extracted among others from the Kesselt plateau in the Maas valley (Belgium) and then enhanced with raw materials from the Volcanic Eifel.

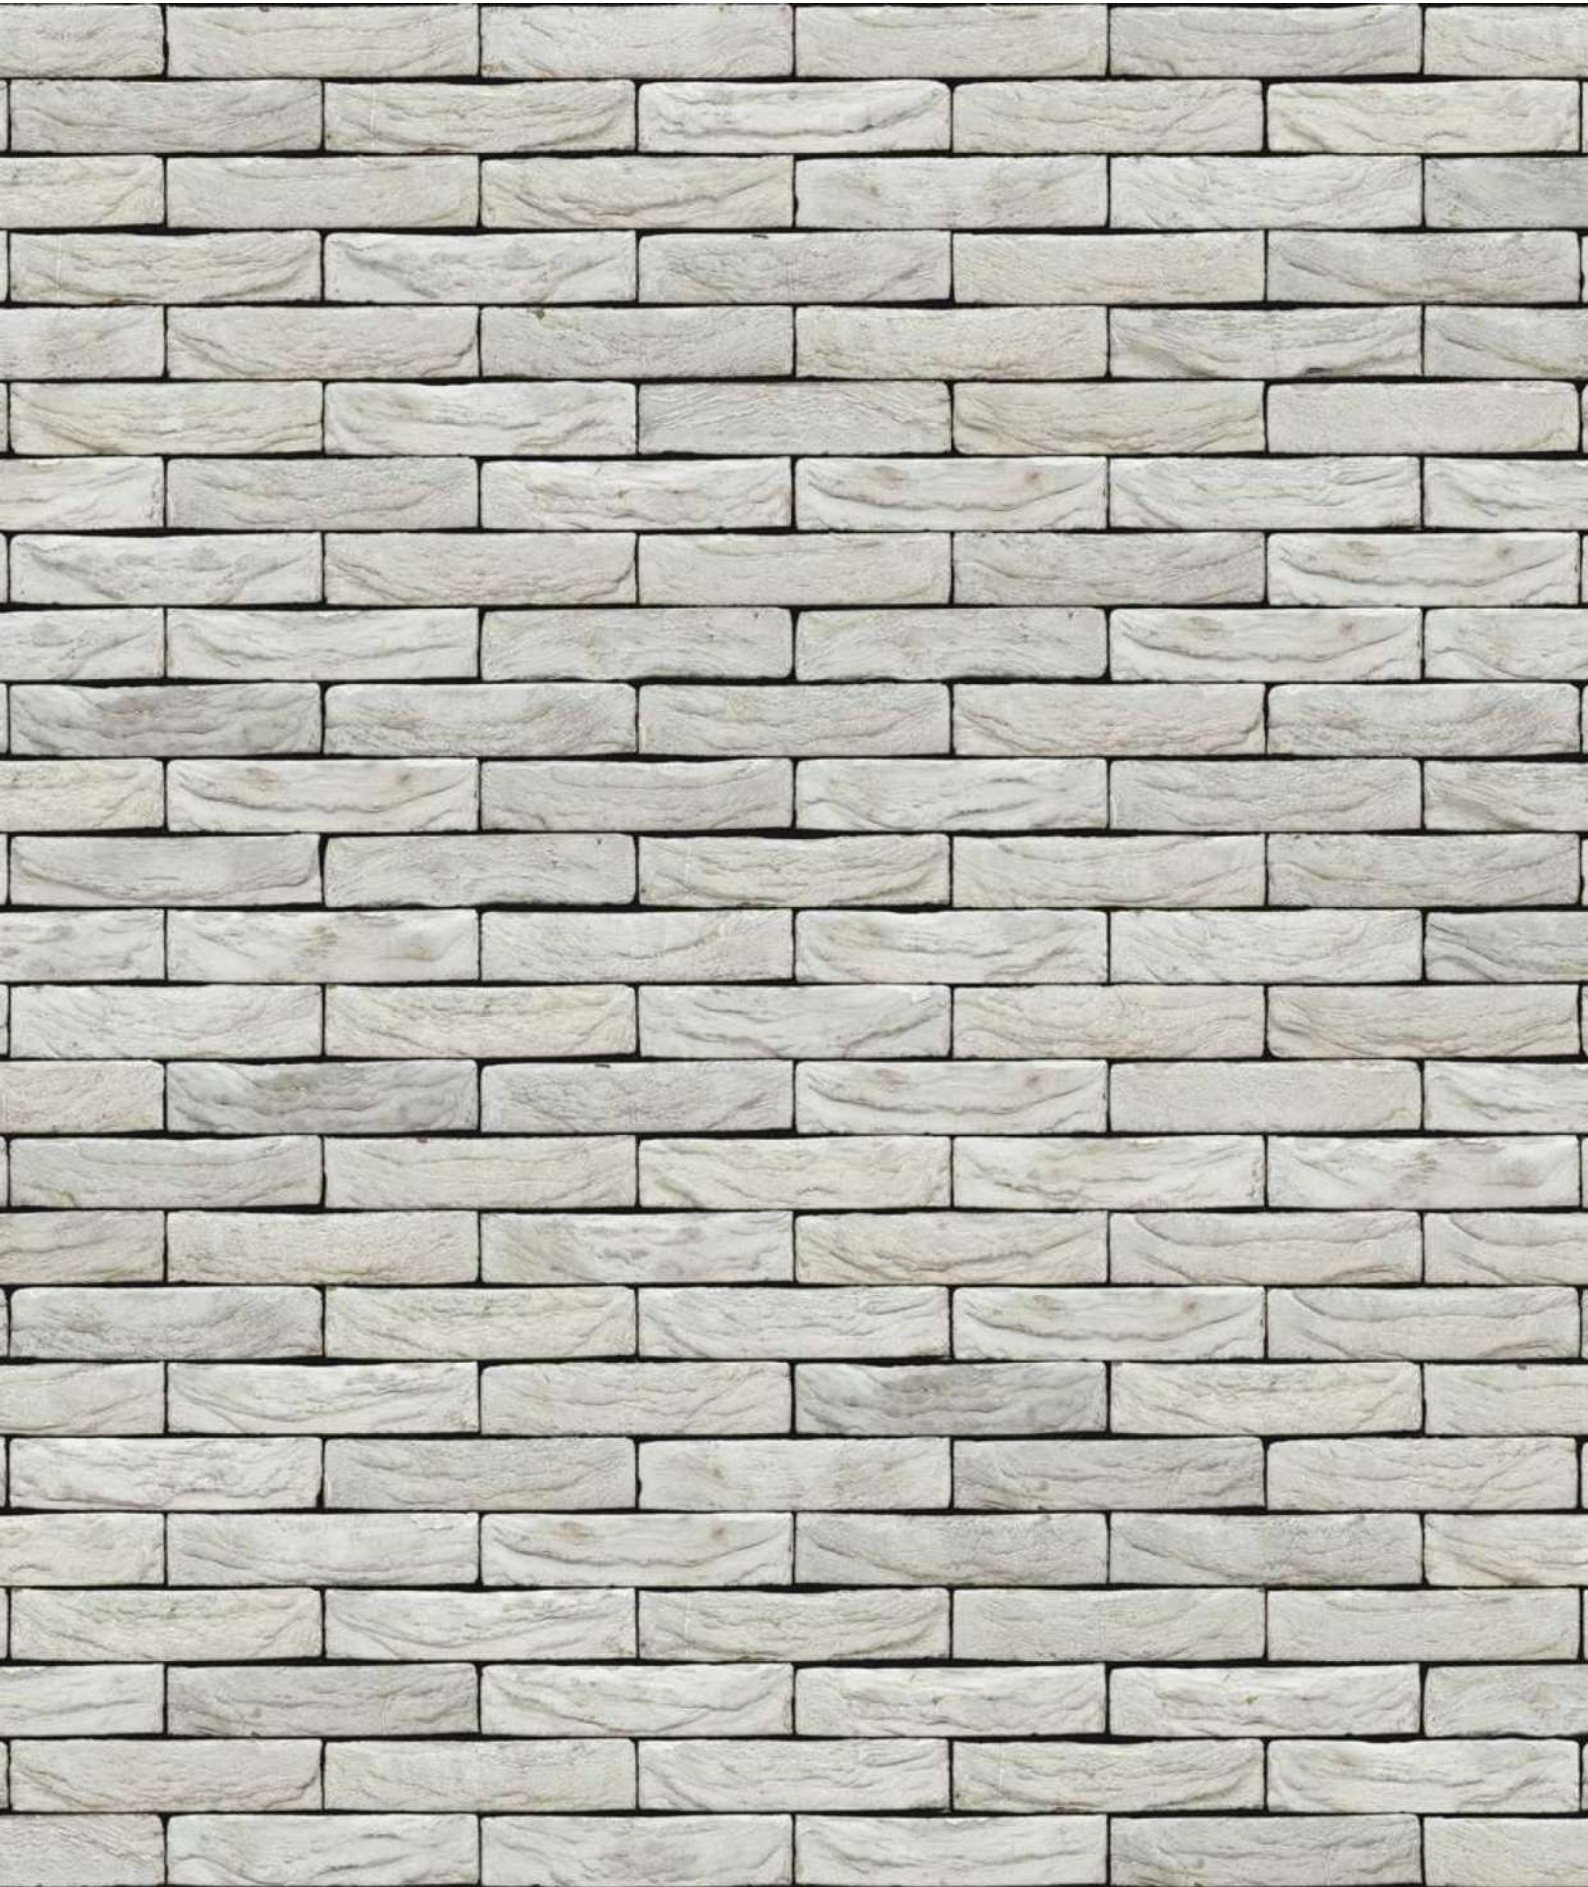
The (non-perforated) facing brick is sanded on five sides. The surface may be given a frog (a slanted oblong groove) on its bed. The structure looks rugged with fine and irregular grooves. The firing process takes place in a gas-heated tunnel kiln. The facing bricks of the Koloro series have a cement coating.

The subsurface is light grey. On the hand-moulded brick a thin white top layer/coating is applied based on a cement mixture. The colour is slightly nuanced. The colour may change in humid conditions, and after drying out the cement coating will get its true colour. The bricks are delivered damp, which causes the colour to differ. After drying out, the cement coating will get the intended colour. The colours shown are a near reflection of reality.
