This hand-moulded facing brick is made from loess, which is extracted among others from the Kesselt plateau in the Maas valley (Belgium) and then enhanced with raw materials from the Volcanic Eifel.

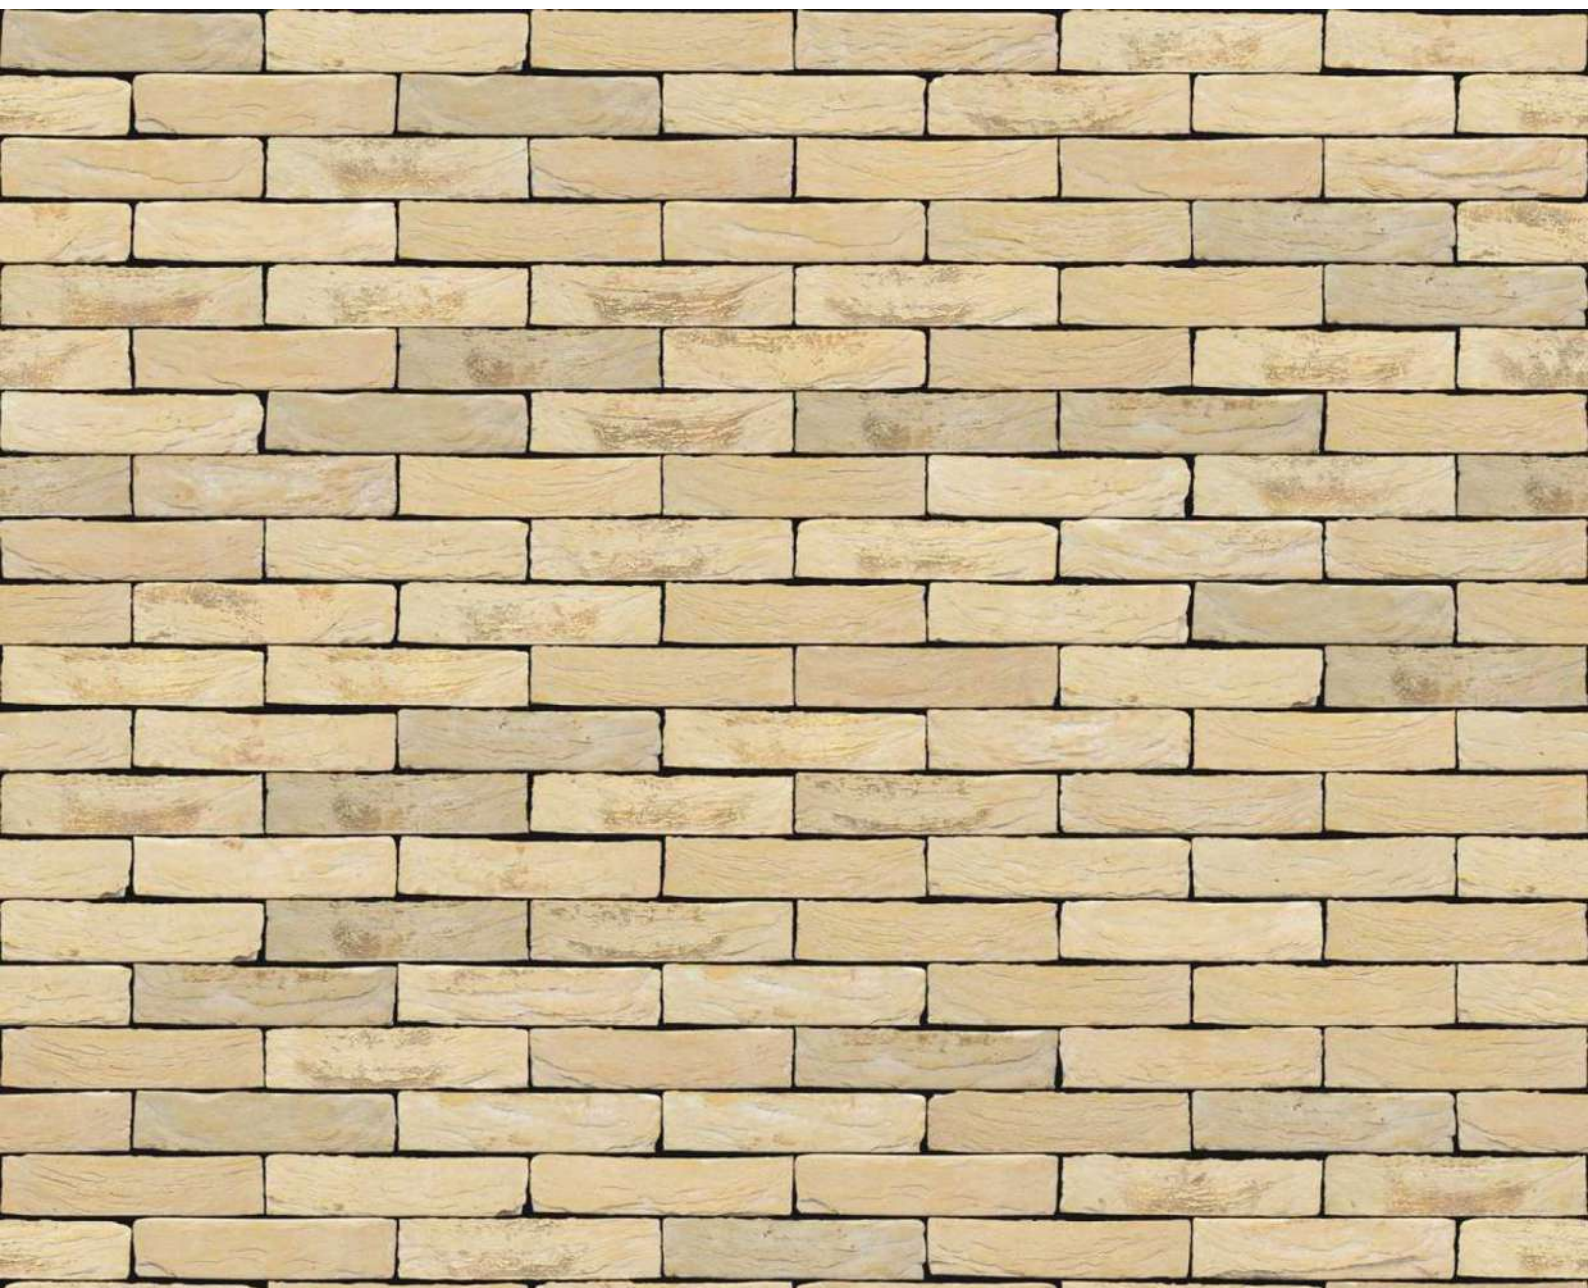
The (non-perforated) facing brick is sanded on five sides. The surface may be given a frog (a slanted oblong groove) on its bed. The structure looks rugged with fine and irregular grooves in the sandy surface. The firing process takes place in a gas-heated tunnel kiln.

The brick has a yellowish base, and the hues are variations on yellow, light-pink and grey shades. The colours shown are a near reflection of reality.
