This hand-moulded facing brick is made from loess, which is extracted among others from the Kesselt plateau in the Maas valley (Belgium) and then enhanced with raw materials from the Volcanic Eifel.

ASPECT AND STRUCTURE

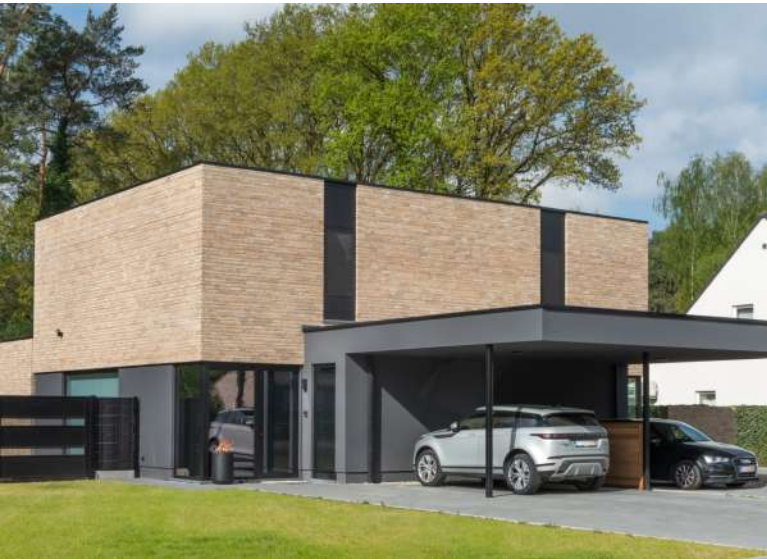
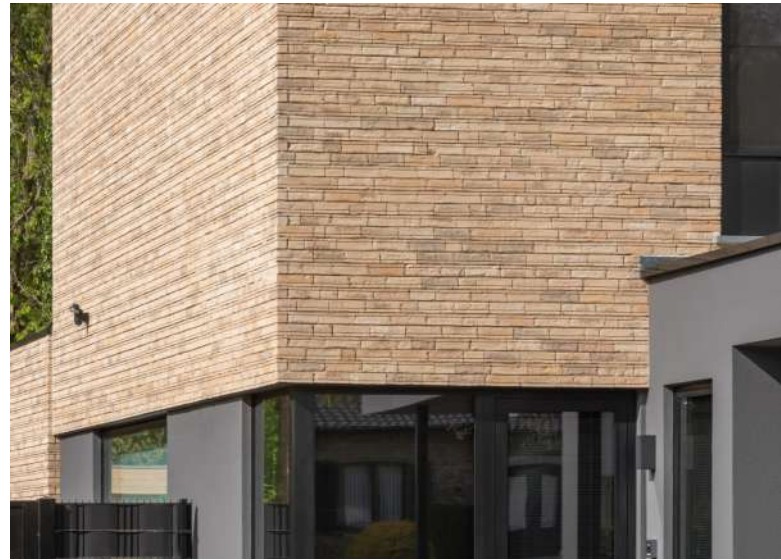
The (non-perforated) facing brick is sanded on five sides. The surface may be given a frog (a slanted oblong groove) on its bed. The structure looks rugged with fine and irregular grooves in the sandy surface. The firing process takes place in a gas-heated tunnel kiln. DUBIO exists in 2 variants: DUBIO 1 = DUBIO with 1 shadow joint on the stretcher face (asymmetrical shadow joint) and DUBIO 2 = DUBIO with 2 shadow joints on the stretcher face (double symmetric shadow joint). The line pattern continues on at least one header face of the brick. The thickness of the shadow joint is ± 4 mm.

The brick has a yellow base. The various types of sand are responsible for colours, ranging from yellow to soft pink with beige, grey and orange shadings. The colours shown are a near reflection of reality.
