This hand-moulded facing brick is made from loess, which is extracted among others from the Kesselt plateau in the Maas valley (Belgium) and then enhanced with raw materials from the Volcanic Eifel.

ASPECT AND STRUCTURE

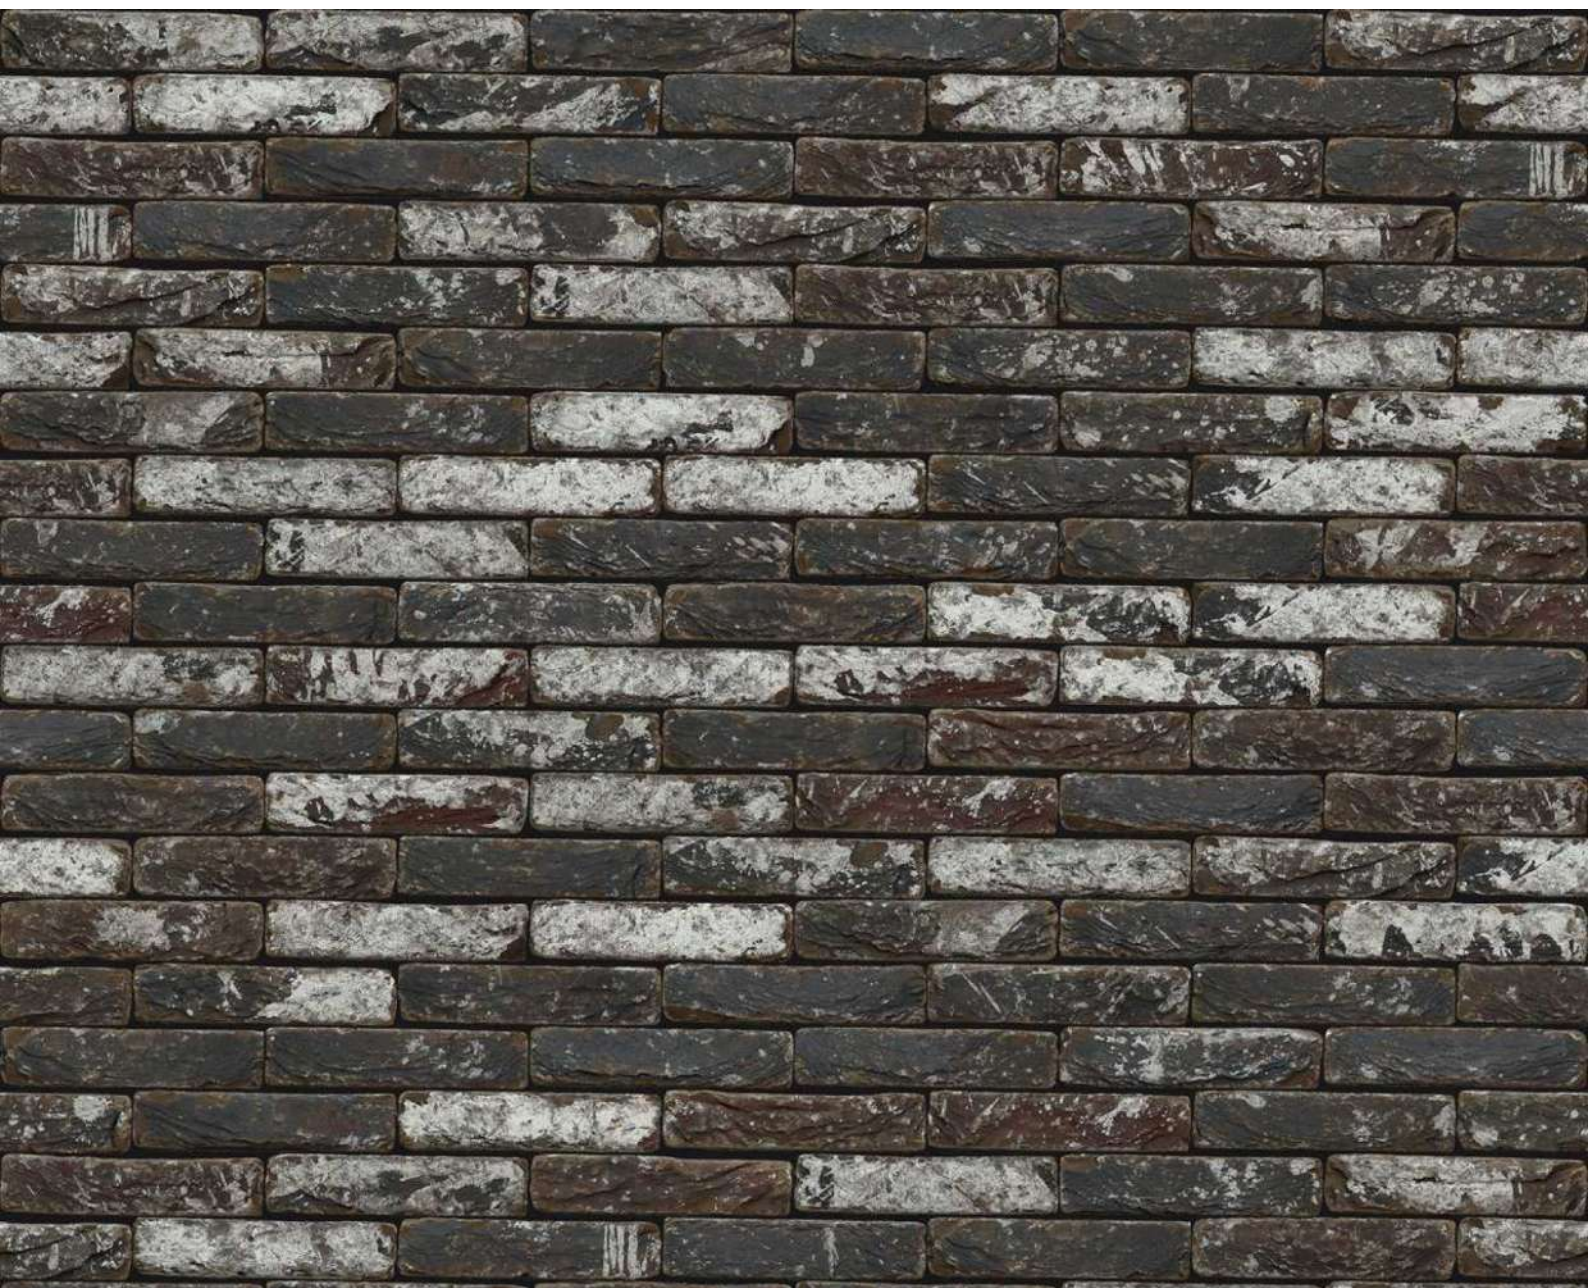
The (non-perforated) facing brick is sanded on five sides. The surface may be given a frog (a slanted oblong groove) on its bed. The firing process takes place in a gas-heated tunnel kiln. The bricks have a rough structure, irregular shape, and a strong resemblance to recovered bricks. The brick's retro appearance is achieved by using a tumbling process.

The colour varies from mainly anthracite to coal black, with blue and brown nuances and white deposits visible. The ageing process also influences the colour shades. The colours shown are a near reflection of reality.
